Construction of Sendai Castle

Sendai Castle's Stone Walls

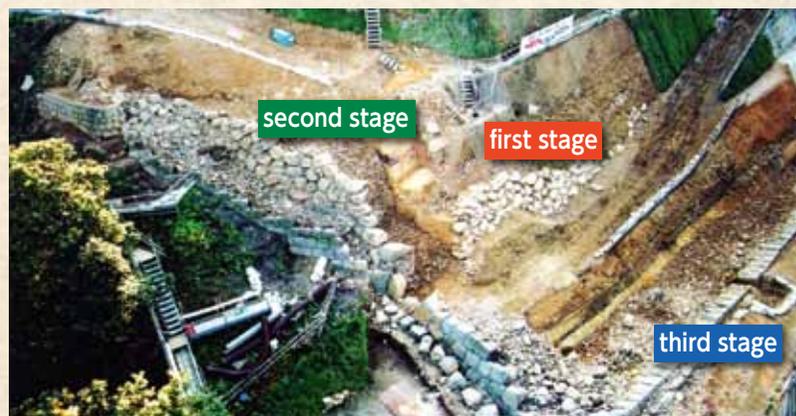
The Main Compound's north stone wall underwent repairs from 1997 to 2004, and in the excavation conducted during construction, an older stone wall, now known to be the second stone wall, was discovered underneath the current stone wall. An even older stone wall, the first stone wall, dates from the beginning of the 17th century when Masamune built the castle, and is made of natural, unhewn stones stacked with their longest side parallel to the wall. The subsequent second stone wall dates from the former half of the 17th century and is made of somewhat shaped natural stones stacked with their longest side perpendicular to the wall. The current third stone wall was built in the latter half of the 17th century during restoration after the 1668 earthquake, and is made of stones hewn on all sides stacked with the joints aligned.

Stone wall on the northeast side of the Main Compound (from the northeast)

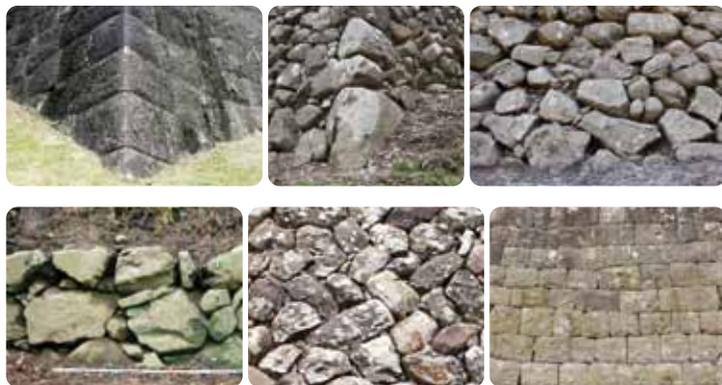
These are examples of various stone walls which allow you to study how those stones had been hewn and how the stones were stacked to form the walls around the castle.

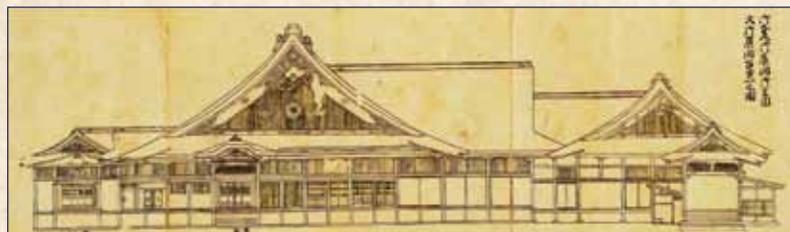
The Main Compound was divided into a public front half and private back half, and contained many buildings. The main building was the Ohiroma, completed in 1610. The Ohiroma was a magnificent building with a total of 14 rooms, and including the porch around its perimeter, had a floor area of about 430 tatami mats. To the north of the Ohiroma was a Noh stage, and another building overhung the cliff to the east.

Chida Family Drawing (Main Compound Ohiroma portion) (Sendai City Museum)

Please see our 1/50 scale model of the Ohiroma based on this drawing and excavations.

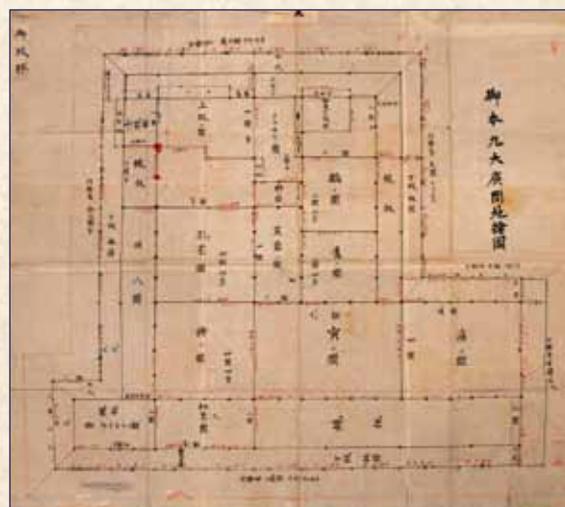
The Jodan-no-ma was a very formal room where the most important ceremonies and meetings between the feudal lord and his retainers were held. It was 7.9m wide, and the alcove contained a wall painting entitled Paulownia and Phoenix by Kano Sakyo. To the north was the Jojodan-no-ma, used during visits from the Imperial Family and the Shogun's family.

Floor Plan of the Main Compound's Ohiroma (Sendai City Museum)
